June 17, 2010

Re: **Special Notice to Olympus Users of STERRAD Sterilization Systems:
Proper Venting of Olympus Fiberoptic/Video Endoscopes using the ETO or
Water Resistant Cap**

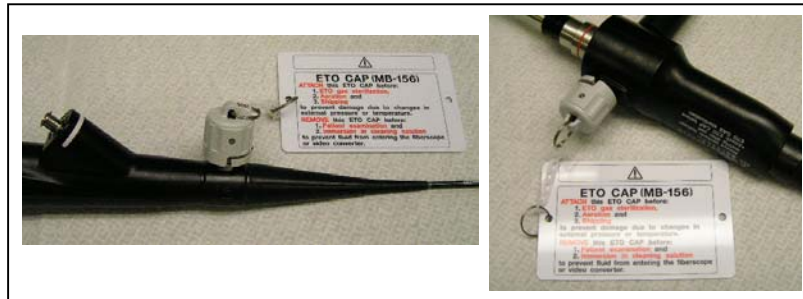
Fig. 1. ETO cap attachment to Olympus fiberoptic/video endoscopes
