Re: Compatibility of Olympus Flexible GI Endoscopes with Compliance™ Sterilizing & Disinfecting Solution

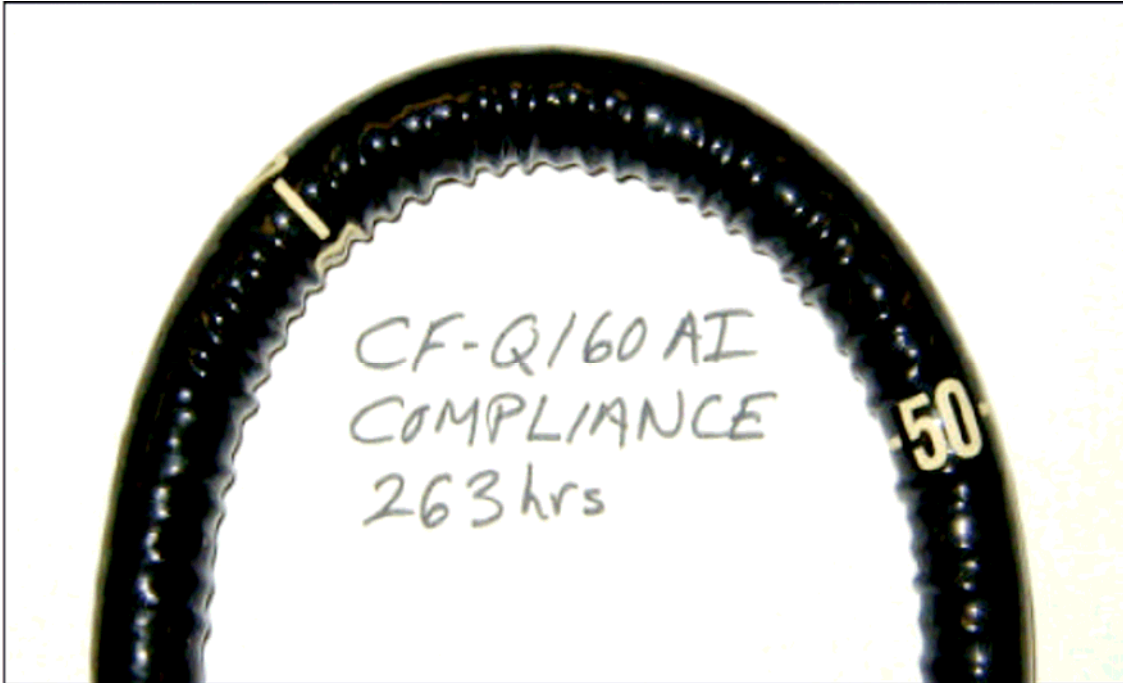
As a screening study prior to more detailed and time-consuming simulated-use testing to investigate whether or not Compliance™ is compatible with Olympus GI endoscopes, Olympus immersed several insertion tubes (models CF-Q160AI & PCF-140I) in the solution for an extended period of time. Within 165 hours of immersion, one of the test insertion tubes had failed due to a swelling and loosening of the black polymer layer of the tube. The polymer layer of the insertion tube lost its adherence to the underlying metal substructure resulting in the creation of ridges and folds in the polymer layer of the tube. Due to the loss of a firm bond between the polymer layer and the underlying metal substructure, the insertion tube lost its normal elasticity and handling characteristics. This “buckling” of the insertion tube worsened with further contact with Compliance™ (refer to Figure 1) and was seen in the other test samples as well.

FIGURE 1. This insertion tube was immersed continuously in Compliance™ for 263 hours at room temperature. The deterioration that caused an early failure of the insertion tube has become even more obvious. The black polymer layer of the insertion tube is swollen and has loosened from the metal mesh below. The white markings have yellowed. The insertion tube has lost its normal elasticity and handling characteristics.

COMPLIANCE™ IS NOT COMPATIBLE WITH OLYMPUS GI ENDOSCOPES.
