June 17, 2010

**Re: Special Notice to Olympus Users of STERRAD Sterilization Systems:
Proper Venting of Olympus Fiberoptic/Video Endoscopes using the ETO or
Water Resistant Cap**

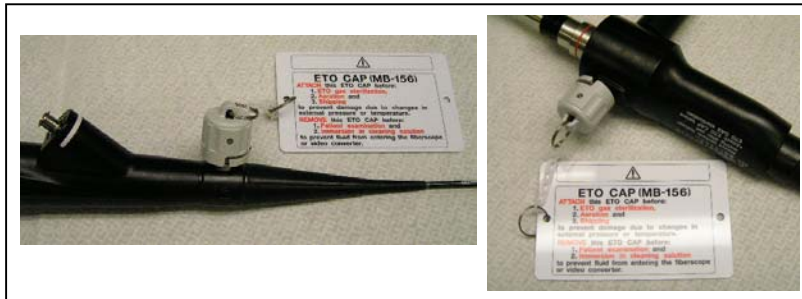
Fig. 1. ETO cap attachment to Olympus fiberoptic/video endoscopes
