**URGENT: MEDICAL DEVICE PRODUCT REMOVAL**

**THUNDERBEAT Hand Instruments**

Date: 22-DEC-2025

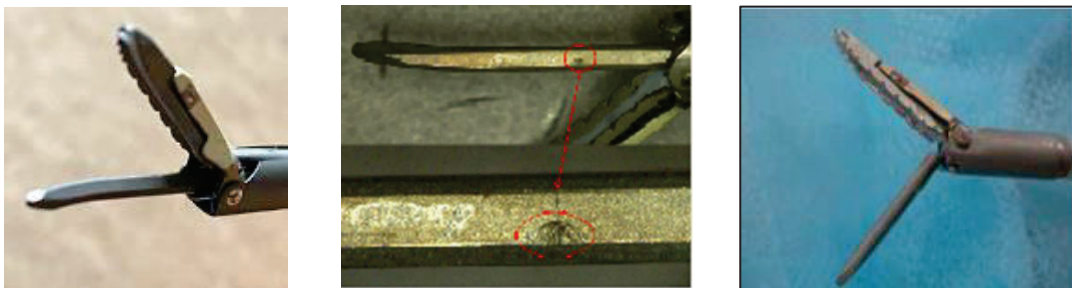
- **Probe tip damage or breakage** - Multiple instances where probe tips of THUNDERBEAT hand instruments have become damaged or broken during use (reference example in Figure 1)
- **Tissue pad issues** - Reports of tissue pad damage or detachment from the instruments (reference example in Figure 2)

Olympus was made aware, via customer complaints, of reports where probe tips of THUNDERBEAT hand instruments are becoming damaged or are breaking (reference example in Figure 1), as well as instances of tissue pad damage or detachment (reference example in Figure 2). Investigations by Olympus demonstrated that these issues can occur when the instructions and warnings in the IFU are not followed, specifically, taking very large bites of tissue, contact with metal while activating, and activation without tissue between the jaws. However, due to a continuation of occurrences of this issue, Olympus is removing potentially affected models of THUNDERBEAT hand instruments from the market.

Figure 1. Example of THUNDERBEAT Probe in accordance with specifications (left), Cracked Probe (Center) and Probe Fracture (right)

1. Examine your inventory for affected THUNDERBEAT hand instrument models as listed on page 1 of this FSN.
2. **Immediately cease use of all affected devices and quarantine the products.**
3. Contact Customer Service at 1-800-848-9024, option 2, to obtain a Return Material Authorization. Olympus will issue a credit to your facility upon return of your affected product.
4. Olympus requests that you acknowledge receipt of this FSN through our web portal:
  - a. Go to <https://olympusamerica.com/recall>
  - b. Enter the recall number "0483"
  - c. Complete the form as instructed.
5. If you have further distributed THUNDERBEAT devices, please identify your customers and forward this notice to them immediately.

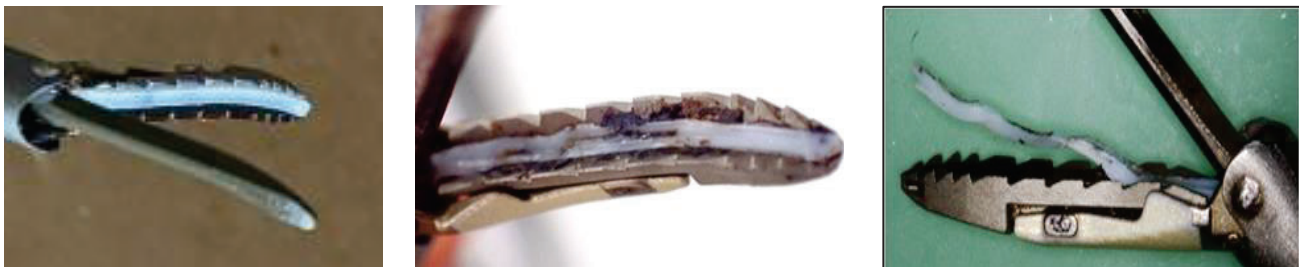
Figure 2. Example of THUNDERBEAT Probe in accordance with specifications (Left), Tissue Pad Deformation (Center), Tissue Pad Detachment (Right)
