URGENT: MEDICAL DEVICE REMOVAL

OLYMPUS ViziShot 2 FLEX

Product Name	Model/Catalog Number	UDI-DI	Lot Numbers
ViziShot 2 FLEX (19G)	NA-U403SX-4019	00821925043060	Refer to Attachment 1

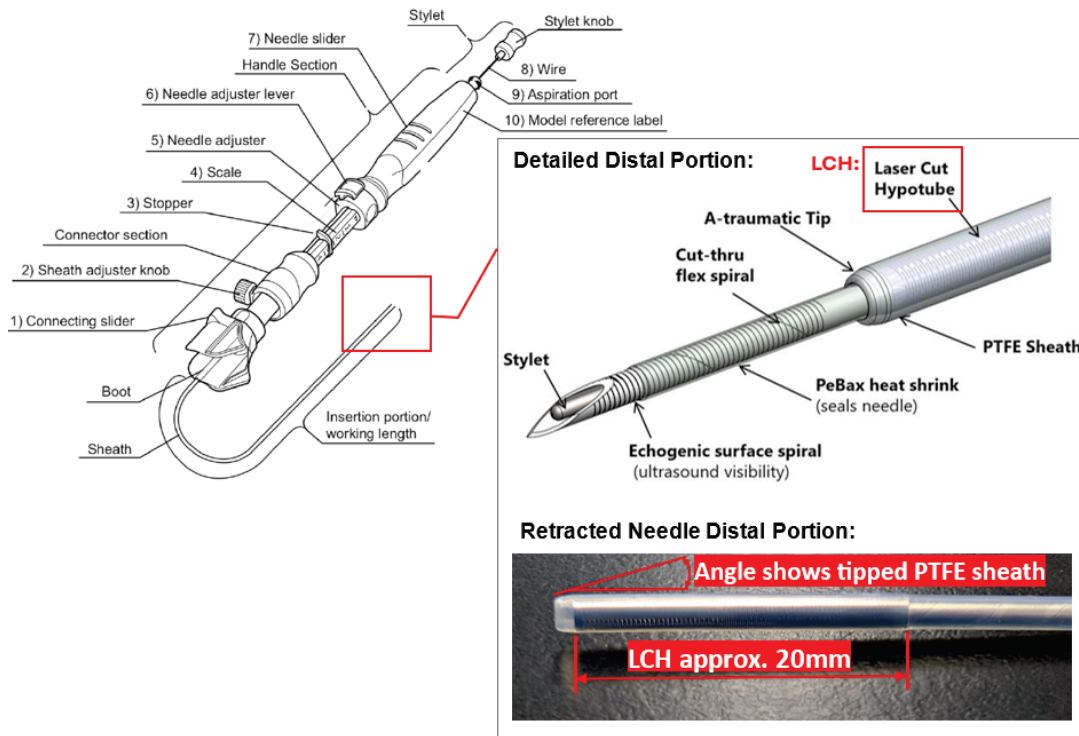
Figure 1: ViziShot 2 Flex Components

Olympus has received a total of 91 complaints for the ViziShot 2 FLEX (19G) device, where the laser cut hypotube component has ejected from the device, or plastic components have detached. See illustration for identification of the hypotube component. Of these complaints, 43 were reported to regulators as malfunctions, 40 were reported as serious injury (or potential for serious injury), and 1 was reported for

potential contribution to a patient death, though a causal relationship could not be determined due to insufficient information received regarding the event. The laser cut hypotube protects the sheath from the needle tip and provides stability during transit and insertion. If device damage occurs, whether detected or undetected and the device continues to be used, the hypotube component has the potential to eject from the device. In addition, if the a-traumatic tip of the ViziShot 2 FLEX (19G) device is improperly formed at the time of manufacturing, and if this is undetected during manufacturing, it could potentially contribute to the likelihood of the hypotube ejecting from the device during use.

If significant resistance is felt while using ViziShot 2 FLEX (19G) during a procedure and the force continues, this could contribute to the risk of device damage and potential patient injury. Therefore, in addition to identified lots of the ViziShot 2 FLEX (19G) devices being removed, **Olympus is also reinforcing the following existing Warnings** from Section 11 of the current instructions for use (IFU, ref: PN0008807_AH) for all users of the ViziShot 2 FLEX (19G):

- If you feel excessive resistance while operating the needle, do not push the needle slider forcibly.
- Do not force the instrument if resistance to insertion is encountered. Confirm the endoscope is straight and in the neutral position. Attempting to force the instrument could cause patient injury, such as perforation, bleeding, or mucous membrane damage. It could also damage the endoscope and/or the instrument.

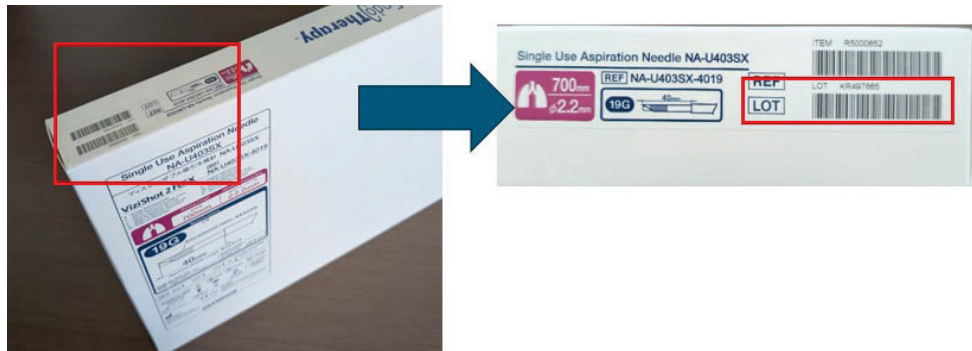
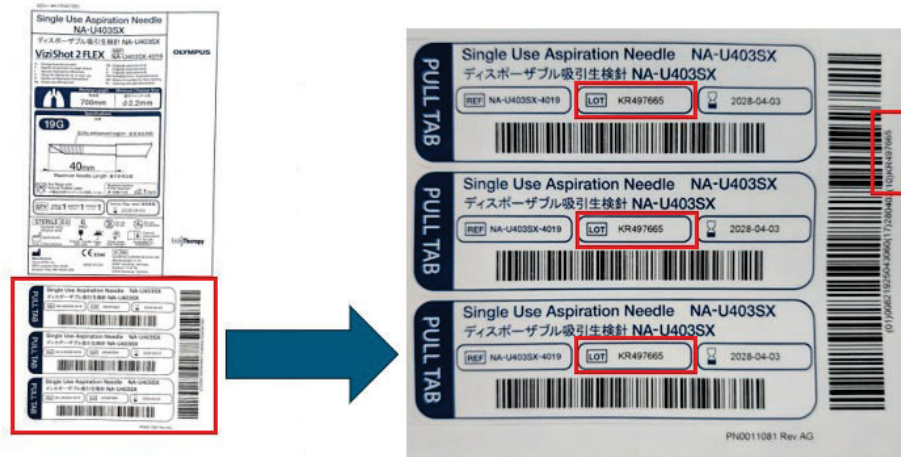
1. Examine your inventory and quarantine any identified devices with the affected lot numbers from Attachment 1. Refer to the below pictures for the location of the lot number:
